# **REAL-TIME MONITORING OF A MULTIPLE RETROGRESSIVE LANDSLIDE**

**A Thesis Submitted to the  
College of Graduate Studies and Research  
in Partial Fulfillment of the Requirements for the  
Degree of Master of Science  
in the Department of Civil and Geological Engineering  
University of Saskatchewan  
Saskatoon, Canada**

**Chad Dennis Salewich**

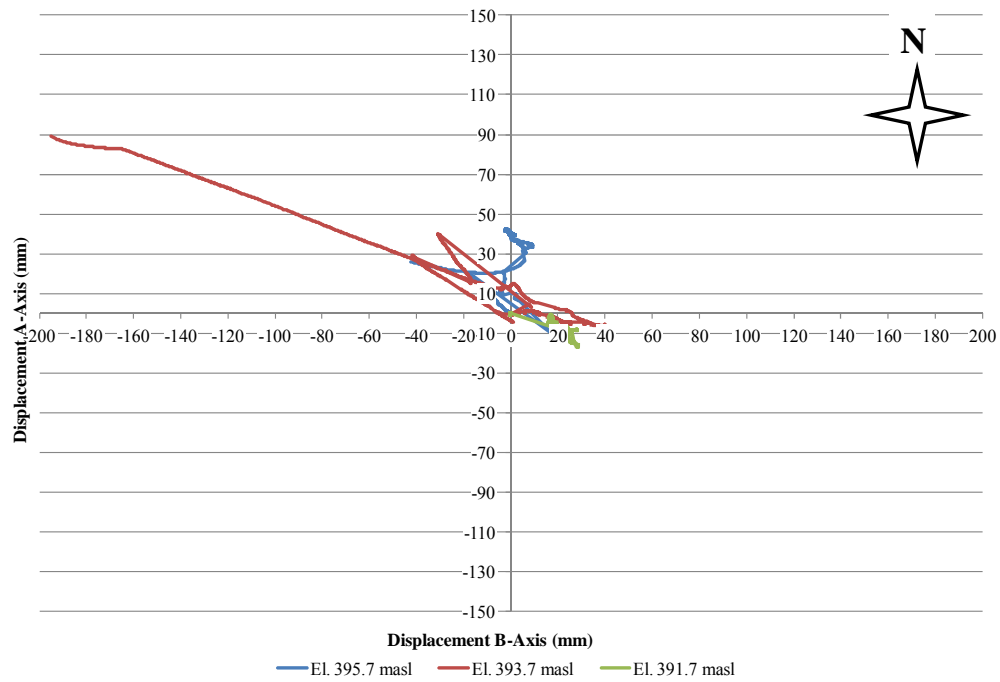
**Figure 5.19: A-Axis versus B-Axis displacement for IPI202 at Highway No. 302 near Prince Albert, Saskatchewan.**

Movement of all three sensors at IPI202 at the Highway No. 302 landslide indicated that the IPIs string was being affected by the casing. The IPIs are changing direction, while at IPI101 at Aylesbury the middle IPIs moves in a constant direction and the ones above and below the shear zone remain very near the origin. This single plot verifies that the IPIs at Highway No. 302 were likely caused by the casing contacting the IPIs.

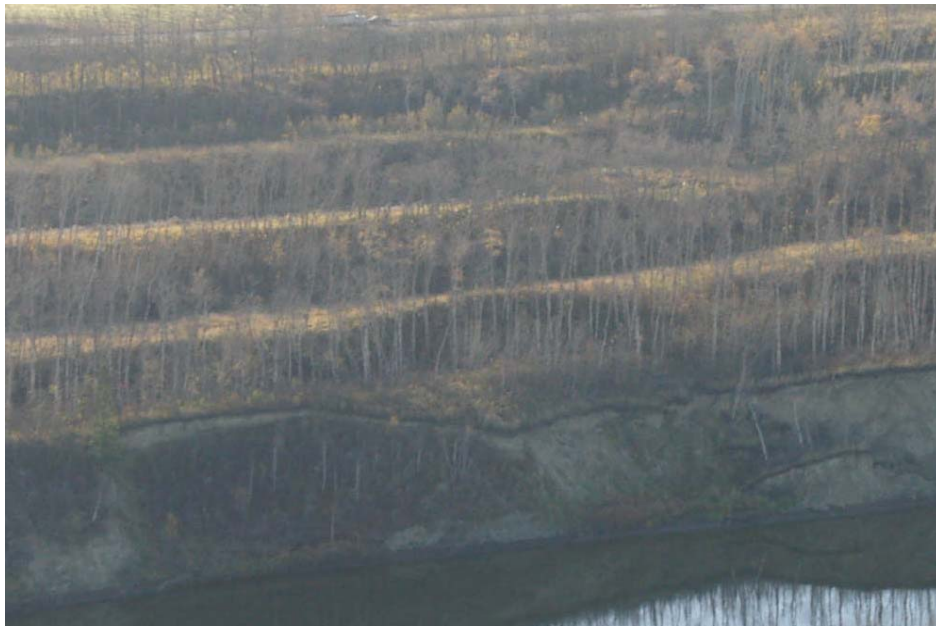
**Figure A. 2: Blocks indicative of a multiple retrogressive landslide, notice Highway No. 302 in the background, Fall 2005 (from Antunes et al. 2006).**

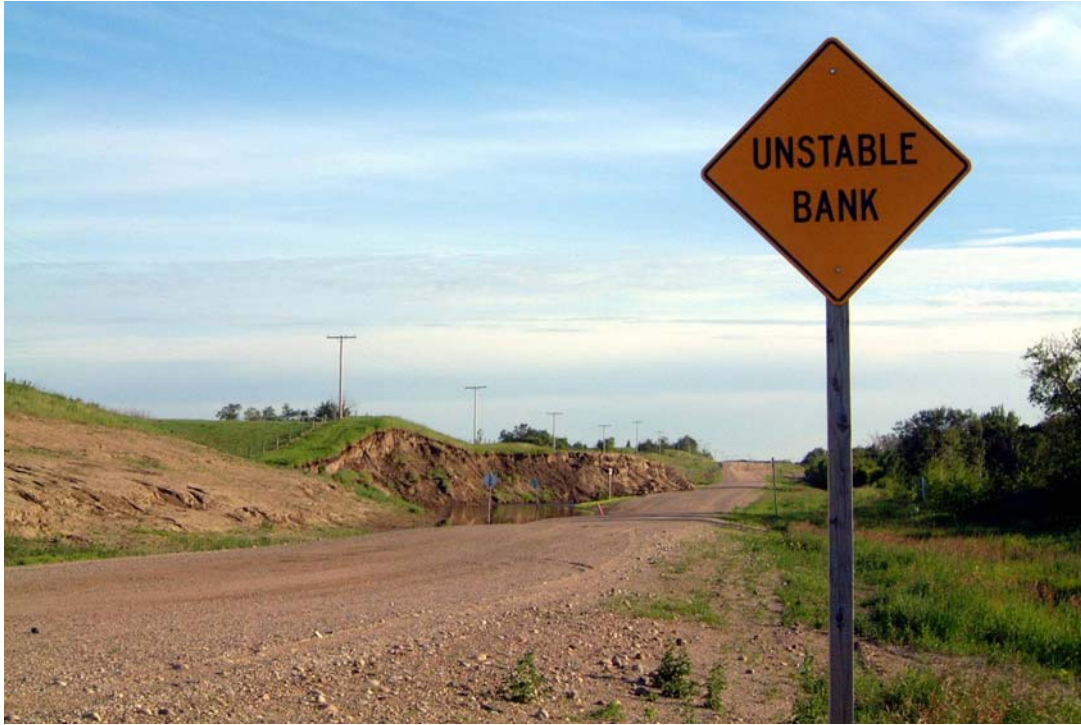
**Figure A. 7: Slope at the end of June 2007 (Photograph by Chad Salewich).**

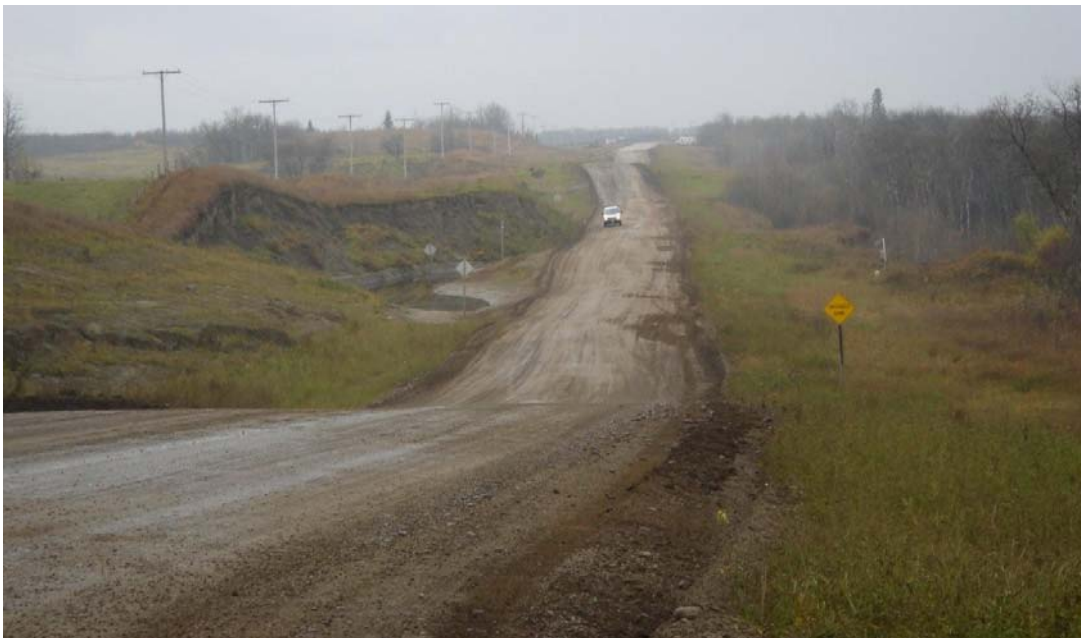
**Figure A. 8: Slope in mid-October 2007 (Photograph by Chad Salewich).**
